Troubleshooting Wind Gearbox Problems

By Jarek Rosinski and David Smurthwaite

In order to prevent in-service failures in wind turbine gearboxes, an in-depth understanding of how and why they occur is required.

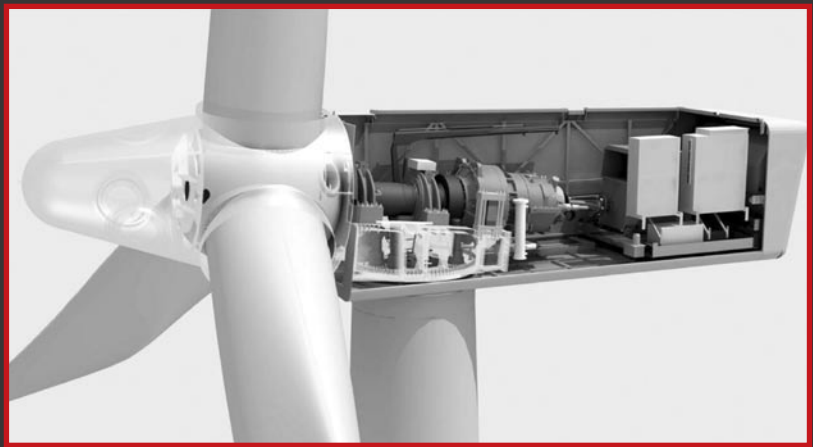
Fig. 1: Layout of a typical wind turbine generator (courtesy of Siemens).

Most wind turbine generators are designed to run at a fixed speed so that the AC electricity is generated at the required frequency. Typically, the components of a large wind turbine generator driveline are the rotor, hub, input shaft, gearbox, disc brake, and generator (see fig. 1).

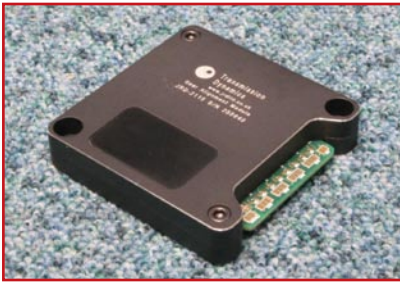
Fig. 3: Transmission Dynamics' state of the art Gear Alignment Module. Size: 60x60x10mm, including Bluetooth communication and integrated long-life battery supply.

The verification of gear geometry using this method for prototype gearboxes of new designs is now commonplace and will become compulsory from 2010. Novel and intricate methods have evolved to enable the extraction of data from complex epicyclic gear sets. Recent tests have been conducted on prototypes of 2MW and 4.6MW gearboxes to verify novel design features and quantify the effects of increased mass associated with additional instrumentation. For information on in-service gear alignment checking, see fig. 3.

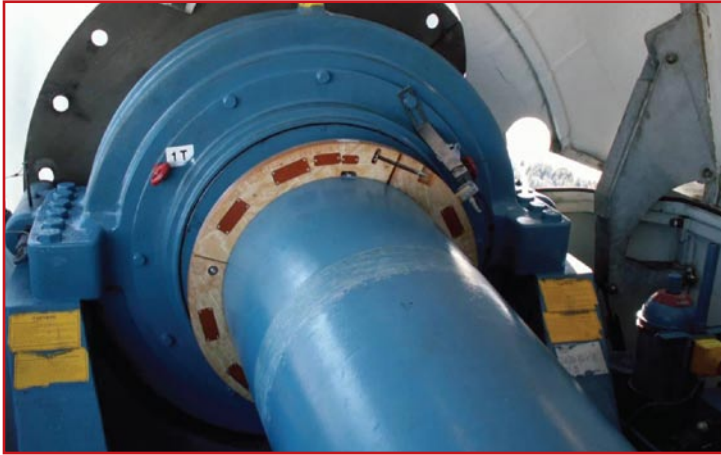
Fig. 4: Input shaft equipped with Transmission Dynamics' torque monitoring equipment.

A system capable of such measurements has been successfully developed and deployed in service. An example of such application on a 1.3MW input shaft is shown in fig. 4. The system used a strain gauges bonded on the input shaft with signal conditioning, amplification, and FM electronics mounted within an annular housing clamped around the shaft.

The signal was wirelessly transferred from the rotating shaft, demodulated and acquired over a two-month period. In this instance batteries were used as a power source, but for longer term monitoring an inductive power supply or a self-inducing power supply is typically used.

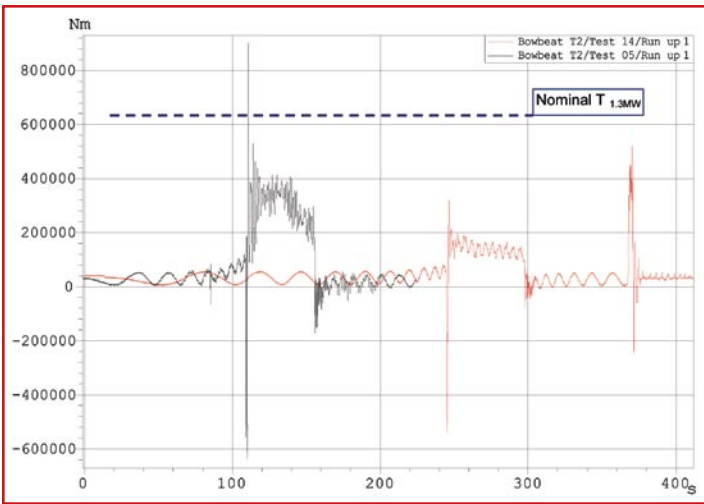
Fig. 7: Input shaft torque for WTG operation in high- and low-power modes.

Input torque is compared for two tests; test 05 (~12 m/s wind) and test 14 (~5m/s wind), as shown in fig. 7. In both cases the data was acquired from rest, with the wind turbine ramping up to synchronous speed, engaged for 20-30s, disengaging and slowing down. Points to note are:

- The much longer time taken to reach operating speed (of only 1000 rev/min) for test 14 compared to test 05, where the operating speed was 1500 rev/min.
- Very large transient events at the time of contactor engagement, resulting in torque levels in excess of that for maximum rated power, in both positive and negative directions.
- The negative torque peak at the point of contactor switching for the low

wind speed was almost as strong as that for the higher wind speed, when operating in a high-power mode.

- The transient torque peak when the brake stops the system (around 370s) is the largest positive torque event for test 14 in the low-power mode. (Note that the actual stopping event was not recorded for test 05).
- The ripple in the torque signal is due to shear load and corresponds

to once per input shaft revolution. The shear load may be due to hub and rotor mass, or misalignment during assembly. This characteristic is seen throughout the test for the red trace (at low wind speed, in low-power mode), and also for the black trace in test 05 during the run-up and slow-down. Torque fluctuation during the period of test 05 when the generator is connected in high-power mode, however, is dominated by three times input shaft speed, i.e. blade passing frequency.

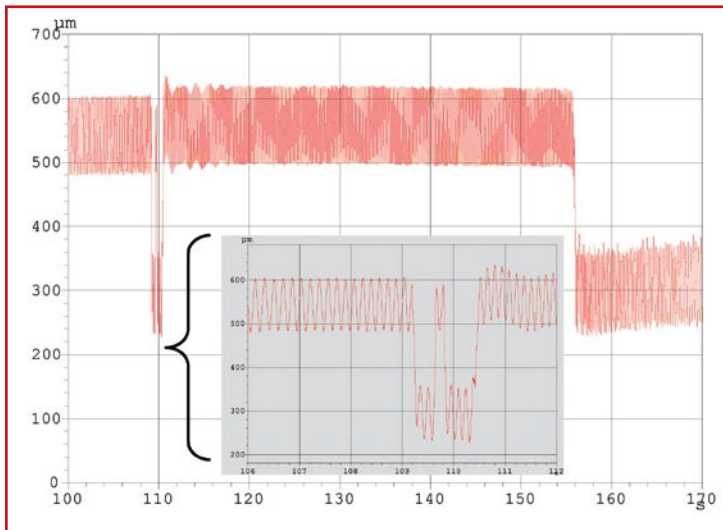
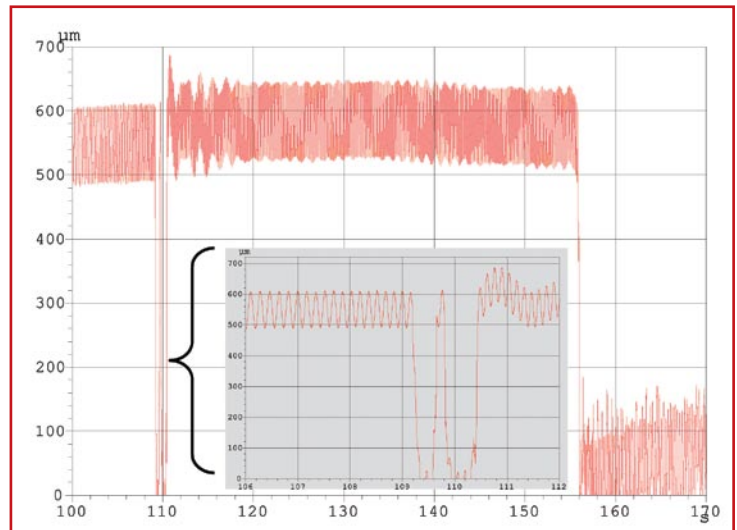
Fig. 11: Test 05—intermediate shaft movement (lateral direction-left graph, vertical direction-right) with detail of the engagement events inset.

Data from the two channels measuring intermediate shaft radial displacement is shown in fig. 11. Generator load was switched on at 110s and off at 156s. There was sudden shaft displacement when the generator was engaged. The lateral movement (200 μm away from the high speed shaft) and vertical movement (550 μm downwards) gave a total displacement greater than 600 μm . The maximum radial clearance specified by INA for bearing type LSL 192332 in this class is only 120 μm (to DIN 620-4 class CN).

The number of transient torque reversals occurring during each engagement cycle varied from test to test. In fig. 11 (test 05) two transient events can be seen as the generator engaged in the high-power mode with a wind speed of around 12ms-1. For test 14 only one single event occurred as the low-power mode was engaged in low wind conditions (see fig. 12). In test 20, however, six events are recorded as the generator engaged with the wind being only just strong enough to operate in the G1 mode (see fig. 13).

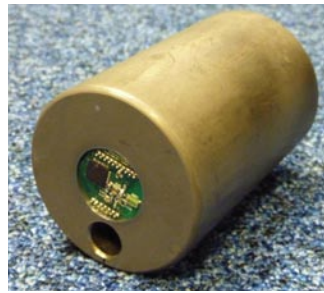
Fig. 17: Rolling element with embedded face load intensity distribution measurement system. High-speed telemetry system operates at 80 ksps, 12-bit SHH and is powered from an integrated miniature battery.

A new test tool is now being deployed which allows the measurement of roller face load intensity distribution during normal operation of industrial bearings. This new instrumentation involves a high-speed digital telemetry system (80 ksps SSH data transfer at 12-bit resolution) built inside the rolling element (see fig. 17). Modern power management techniques allow operation of the smart roller for up to three months on one coin battery.
